Brushy Creek Stream Restoration

BMP Demonstration Project

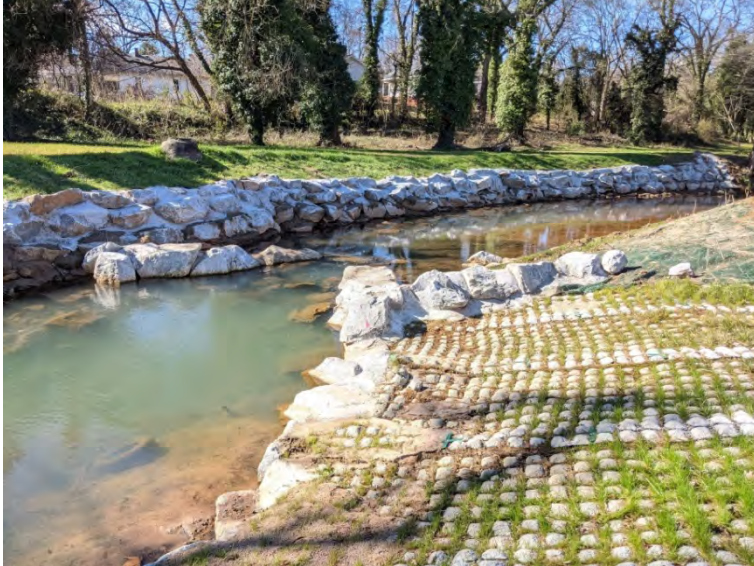
Boulder Wall & Enkamat

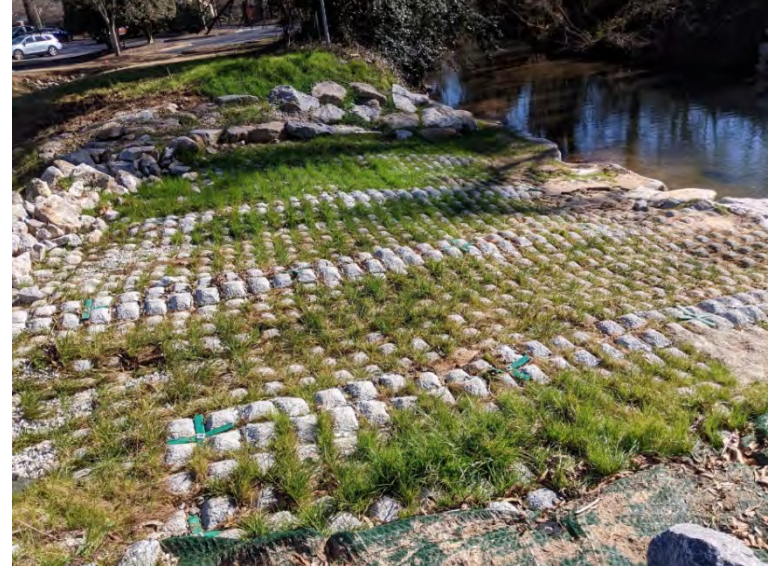
Flexamat

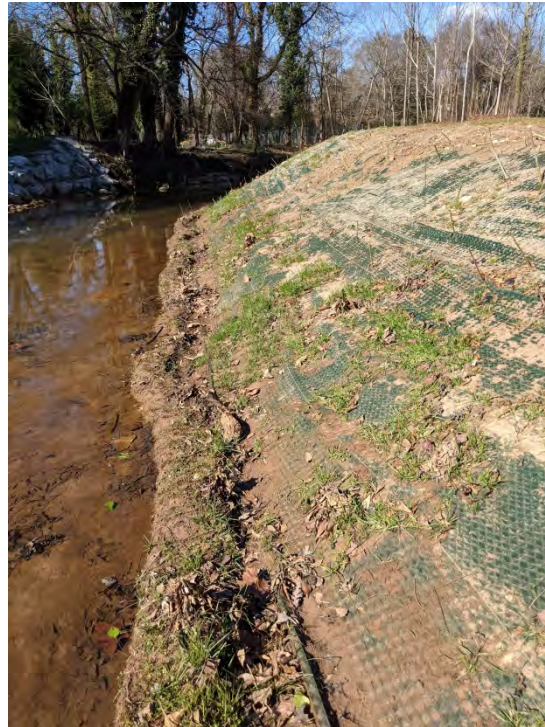
Coir Log & Pyramat

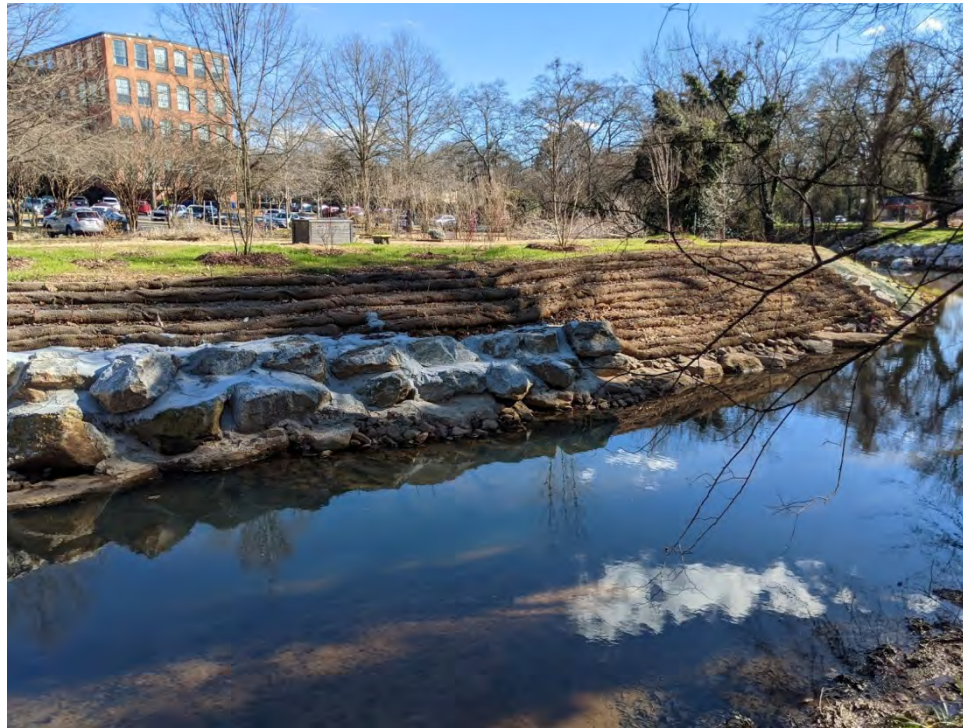
Boulder Wall and Soil Lifts

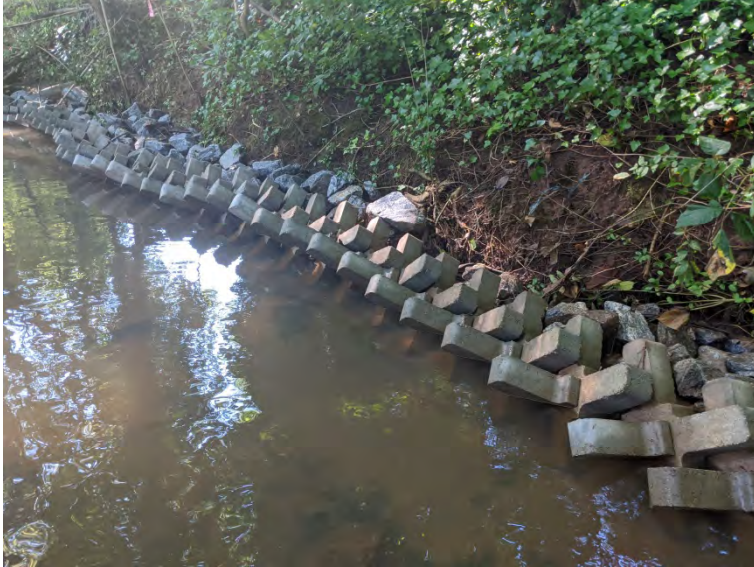
A-jacks

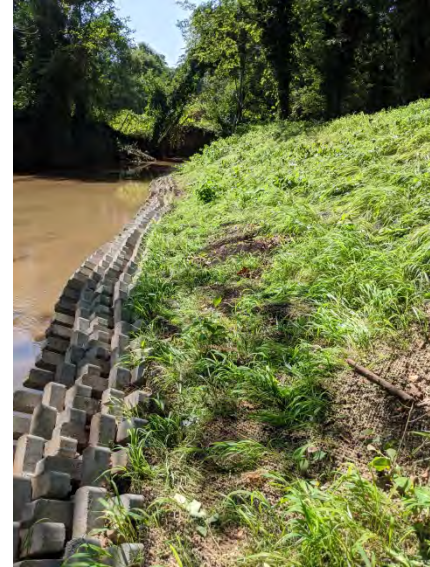
Enkamat

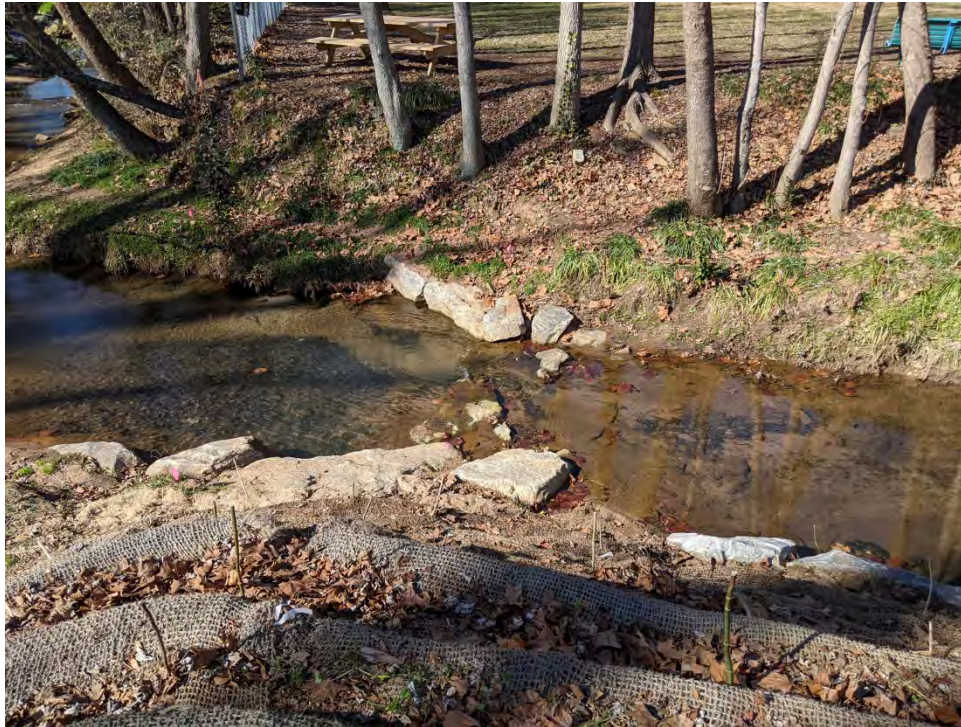
Cross Vane

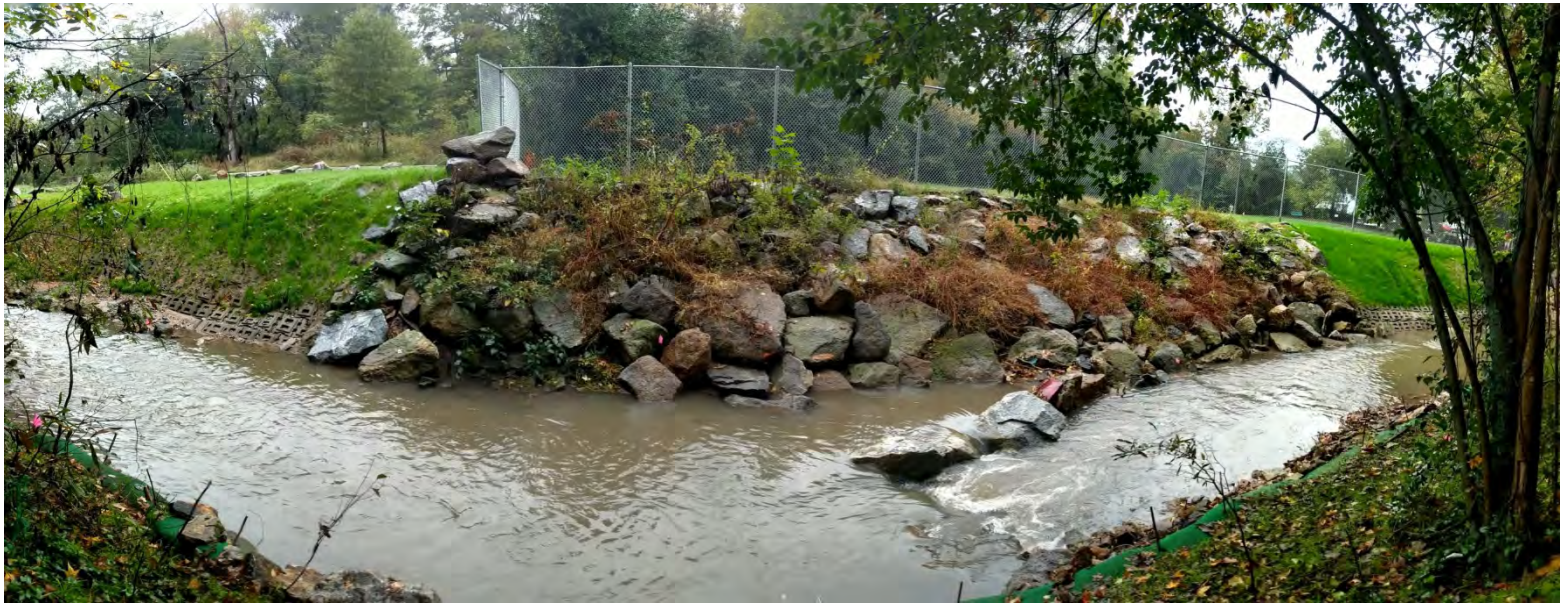
Single Vane

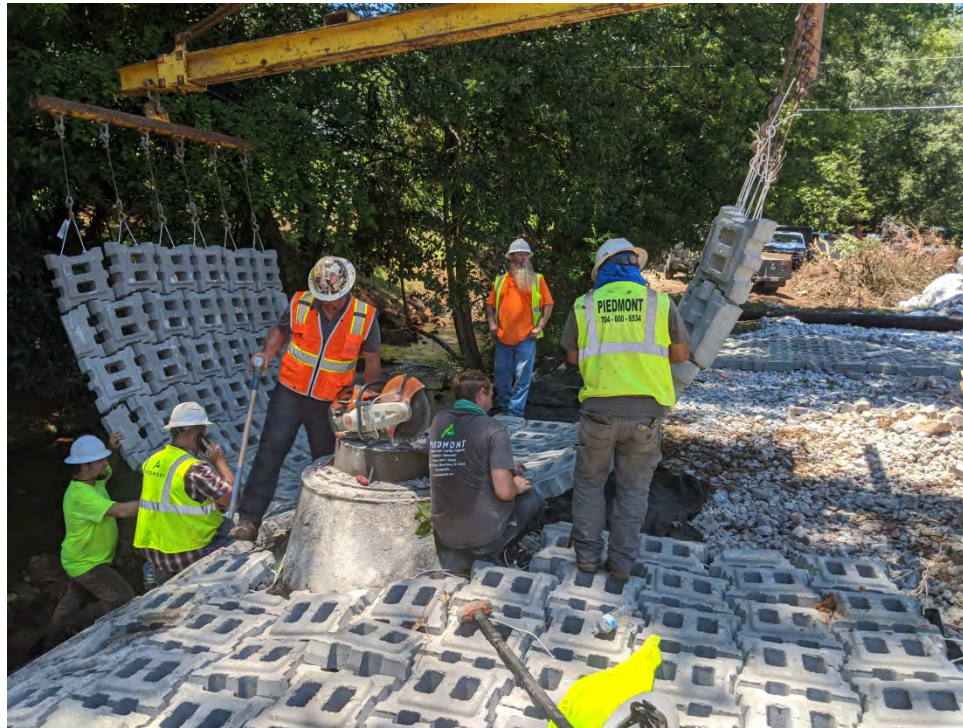
Shorelock Installation

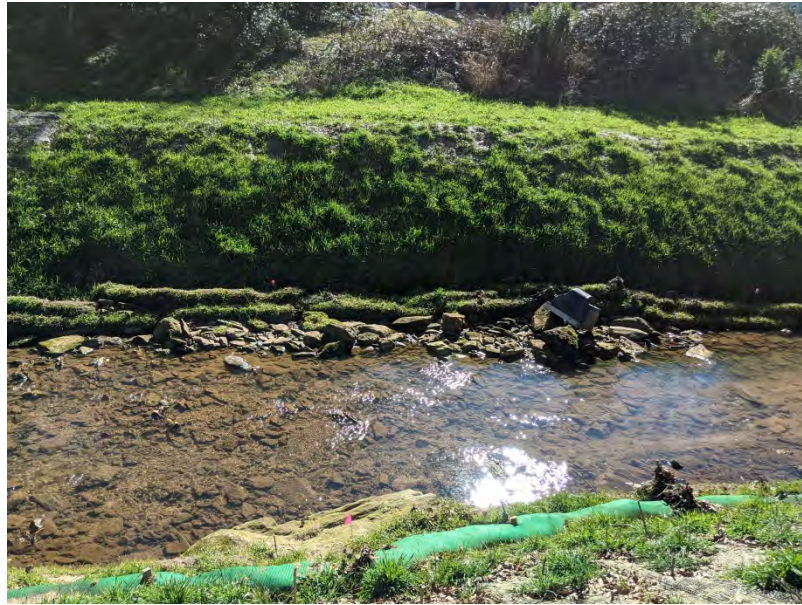
Coir Logs & ECSCC-3 Matting

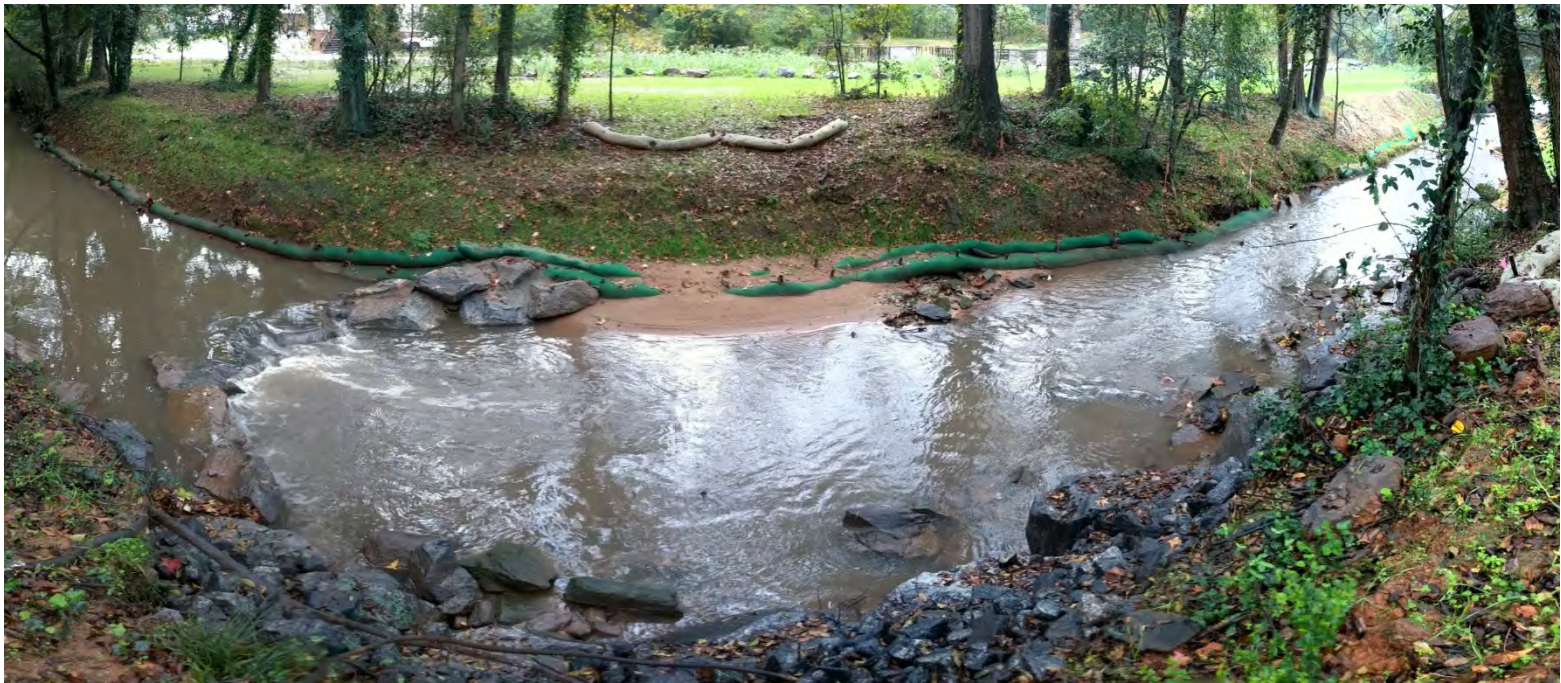
Cross Vane

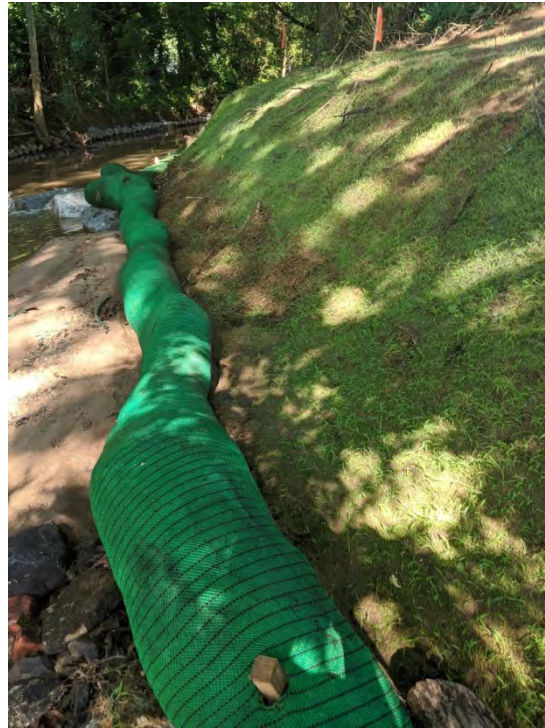
Compost Sock & Coir Matting
